PRELIMINARY REPORT OF SURVEY

Report no.: N 59116/05

Container No. : MAEU 600017-6 (20')

REPORT OF SURVEY

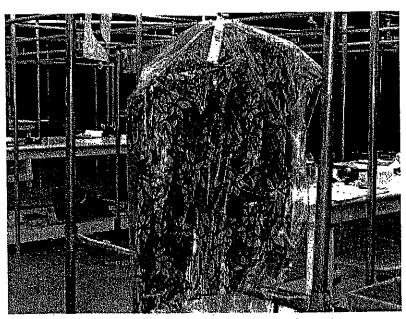
The three samples after dry cleaning still retained the odor even though there were no stains on any of the clothing.

12. The dry cleaned garments with the odor still present

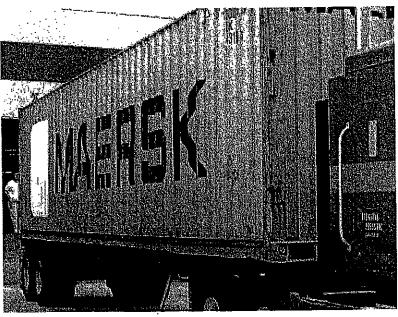
Old minor dents and rust areas. Front panel 3.

09. Shows the rust on the front comer
